Re: May 2015 Monthly Progress Report
Administrative Settlement Agreement and Order on Consent for Removal Action
U.S. EPA Region 10 Docket No. CERCLA 10-2009-0255
Gasco Sediments Site within the Portland Harbor Superfund Site

Attachment A Monthly Visual Monitoring Report for Pilot Cap Vicinity

Visual Observations Log Form

Monitoring Period: Monthly (Year 9) — May 2015

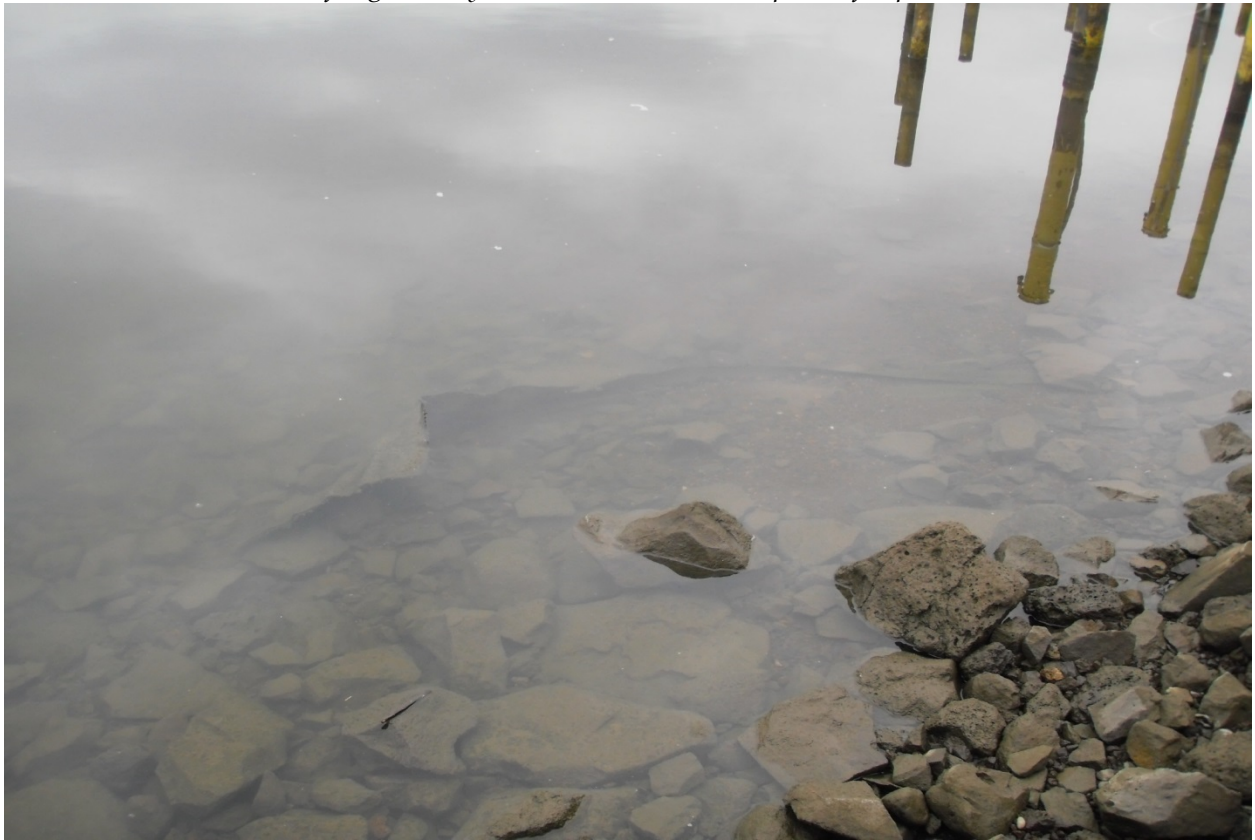
Observations of Erosion/Deposition: No erosion / deposition was observed along the shoreline. All previously noted organo-clay mat material segments are underwater due to higher river elevations. Two segments are visible in 0.5 to 1 feet of water including a 10-foot section near the downriver extent of the cap area and a 5-foot section near the lateral midpoint of the cap area (Photo 1).

Photo 1 — *Visible section of organo-clay mat near the lateral midpoint of cap area (5/19/15):*

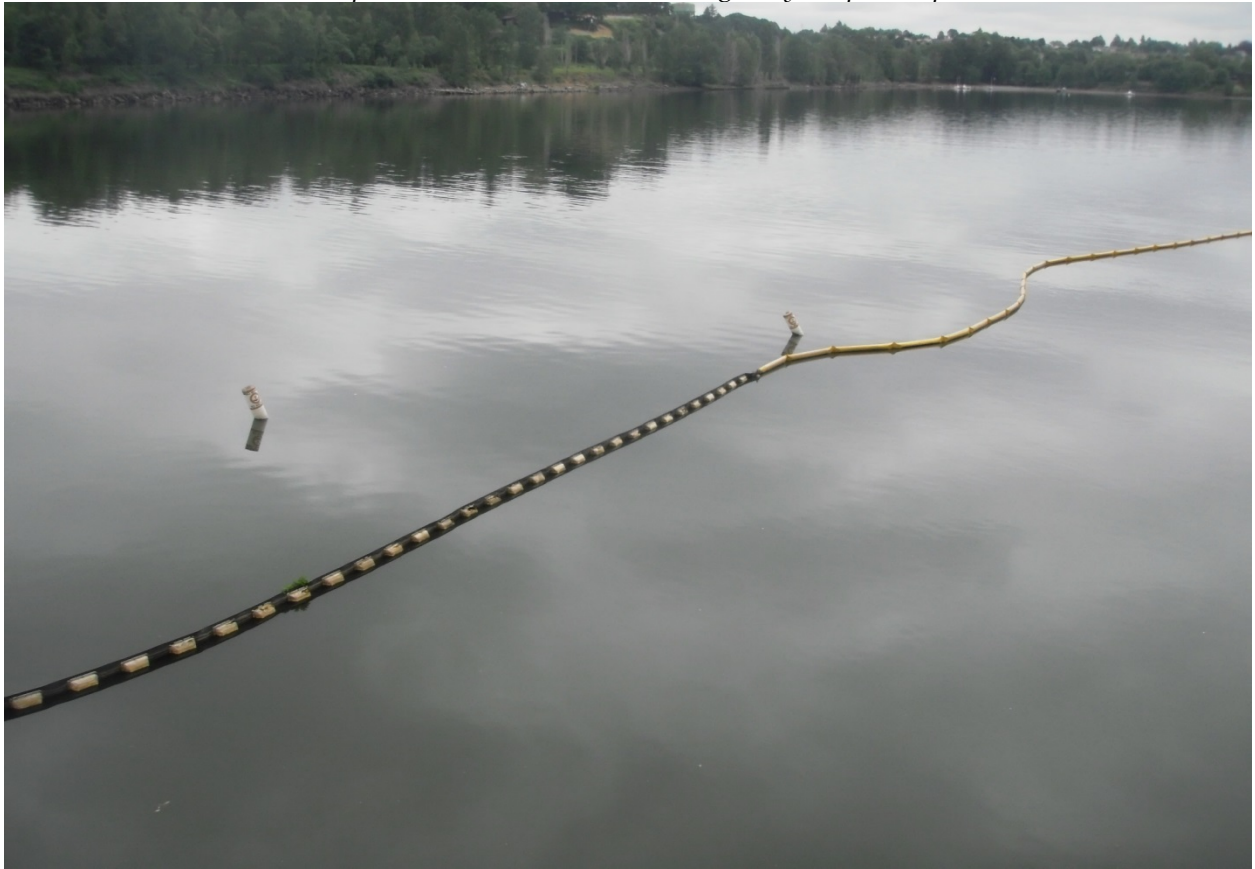
Observations of Long-term Controls (i.e., oil booms, organo-clay mat, etc.) During the observation, the Fuel and Marine Marketing (FAMM) containment boom was in place, across the cap area, between the upriver corner of the ship dock and the wooden dolphin (near the upriver extent of the site and near the Siltronic Corporation outfall). Two buoys that identify the cap area to mariners are in place as installed. The position of the FAMM oil boom, warning buoys, and a general overview of the site shoreline is shown in Photo 2.

Photo 2 — *FAMM oil boom placement and mariner warning buoys at pilot cap area (5/19/15):*

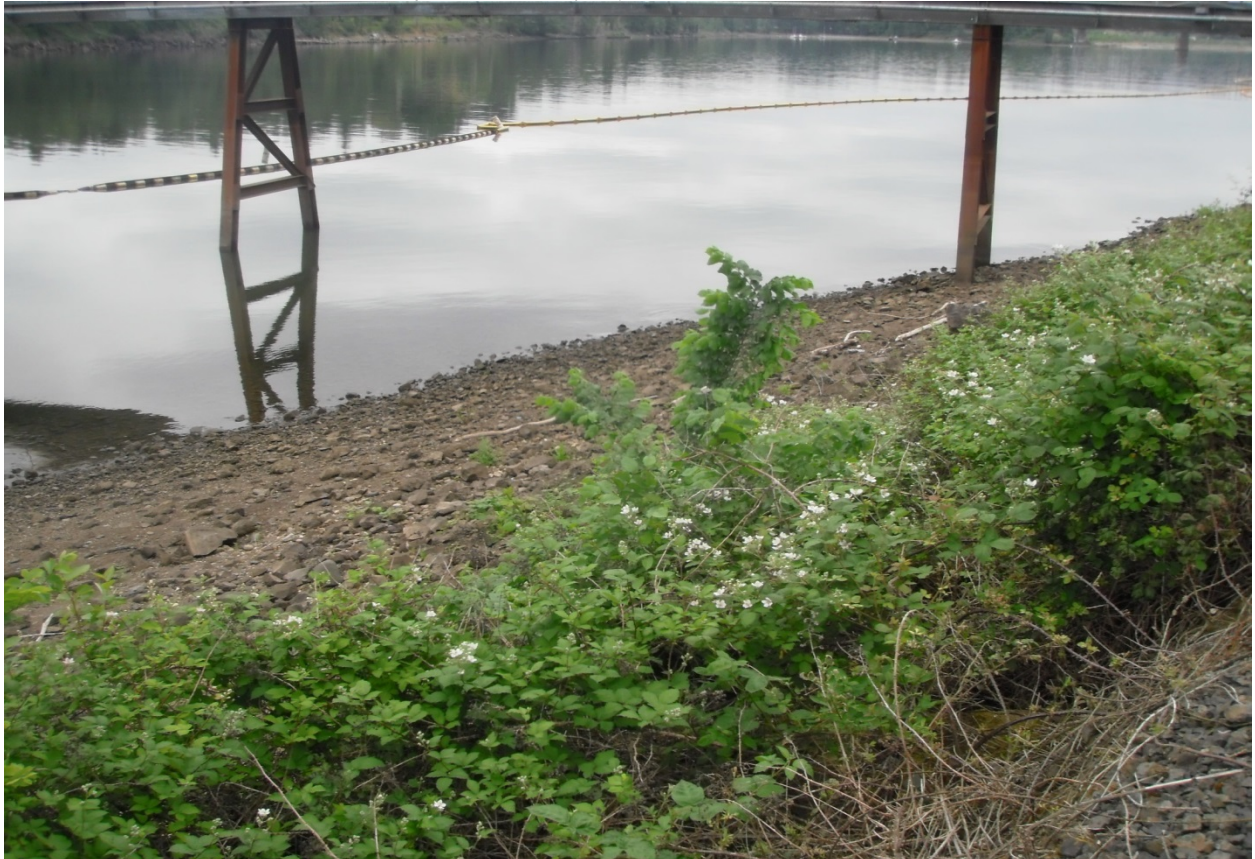
No sheen is evident in or around the cap area. Photo 3 shows the water surface and shoreline immediately downriver of the sediment cap.

Photo 3 — *Conditions immediately downriver of cap area (5/19/15):*
